**Flood Control Project Maintenance
Levee Inspections**

Maintenance Issue Types Only, Levee Inspection Report By Mile - Spring 2017

Reclamation District No. 0369 Libby McNeil

Waterway	Bank	Unit Miles	Inspection Start/End	Inspector
Unit No. 01 Sacramento River	Left	0.78	04/04/2017 04/04/2017	Herman Phillips

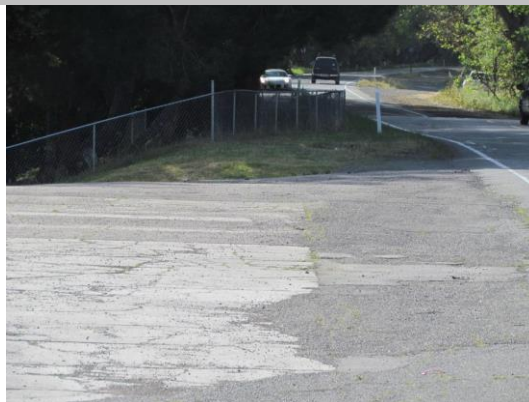
Photo 1 of 1 : SP_2017_RD0369_207_10_20170405_00021.jpg

LM Start	0.16	Rating **	M	Issue No.	10
LM End	0.23	Issue Type +	Ma	Location *	LS
Category	Earthen Levee			GPS Latitude/Longitude	
				Start	End
Item	Vegetation			38.257292 °	38.256660 °
				-121.515690 °	-121.514710 °
DWR ID	DWR_RD0369_01_s_2017_10				
Comment Code					
V2 : Remove the wild growth other than native grasses from the levee slopes.					
Inspector Comment					
Spray or mow the weeds along the landside levee slope.

Looking downstream from the landside shoulder.

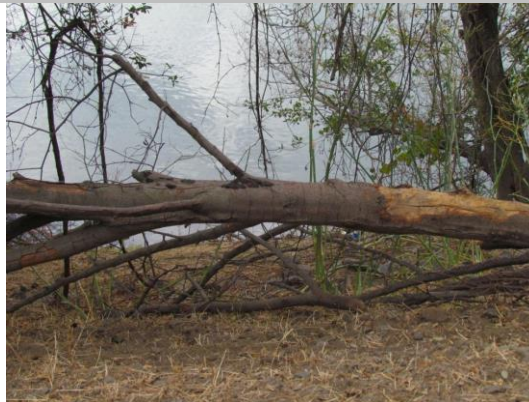
Photo 1 of 1 : SP_2017_RD0369_207_16_20170404_00002.jpg

LM Start	0.53	Rating **	M	Issue No.	16
LM End	0.53	Issue Type +	Ma	Location *	WS
Category	Earthen Levee			GPS Latitude/Longitude	
				Start	End
Item	Encroachments			38.253095 °	38.253095 °
				-121.511387 °	-121.511387 °
DWR ID	DWR_RD0369_01_s_2016_16				
Comment Code					
TR : Tree or limb					
Inspector Comment					
Cut up and remove the dead tree from the waterside slope. This tree was reported during spring inspection 2016.

RD 369 Levee mile 0.53 waterside levee slope.

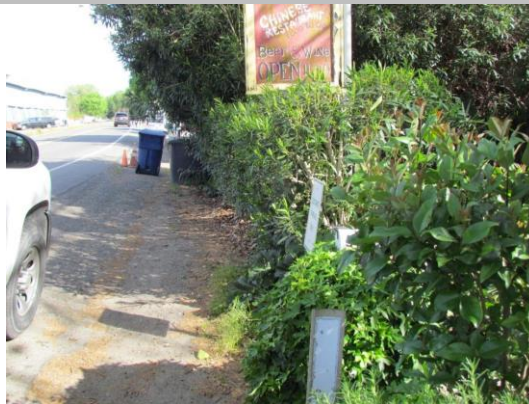
Photo 1 of 2 : SP_2017_RD0369_207_8_20170405_00023.jpg

LM Start	0.75	Rating **	U	Issue No.	8
LM End	0.77	Issue Type +	Ma	Location *	LS
Category	Earthen Levee			GPS Latitude/Longitude	
				Start	End
Item	Vegetation			38.250215 °	38.249930 °
				-121.509990 °	-121.509880 °
DWR ID	DWR_RD0369_01_s_2017_8				
Comment Code					
V7 : Trees / Woody Vegetation					
Inspector Comment					
District need to control the woody tree and vegetation growth along the landside levee section.

Looking upstream from levee mile 0.77 to levee mile 0.75 at the woody tree and vegetation on the landside slope.

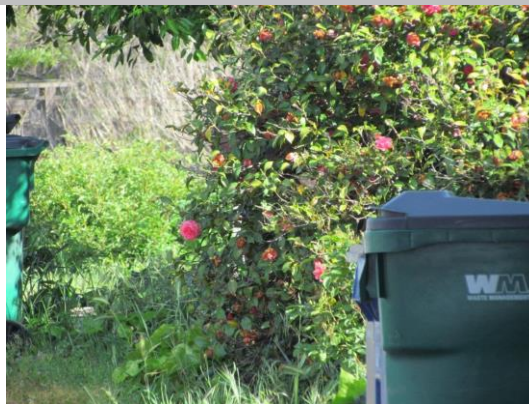
Photo 2 of 2 : SP_2017_RD0369_207_8_20170405_00024.jpg

Looking upstream from levee mile 0.77 to levee mile 0.75 levee slope blocked by vegetation typical view of growth along this section.
